Reliability and Maintainability Evaluation of the Mode S System

Prepared By
FAA Technical Center
Atlantic City Airport, N.J. 08405

May 1982

Final Report

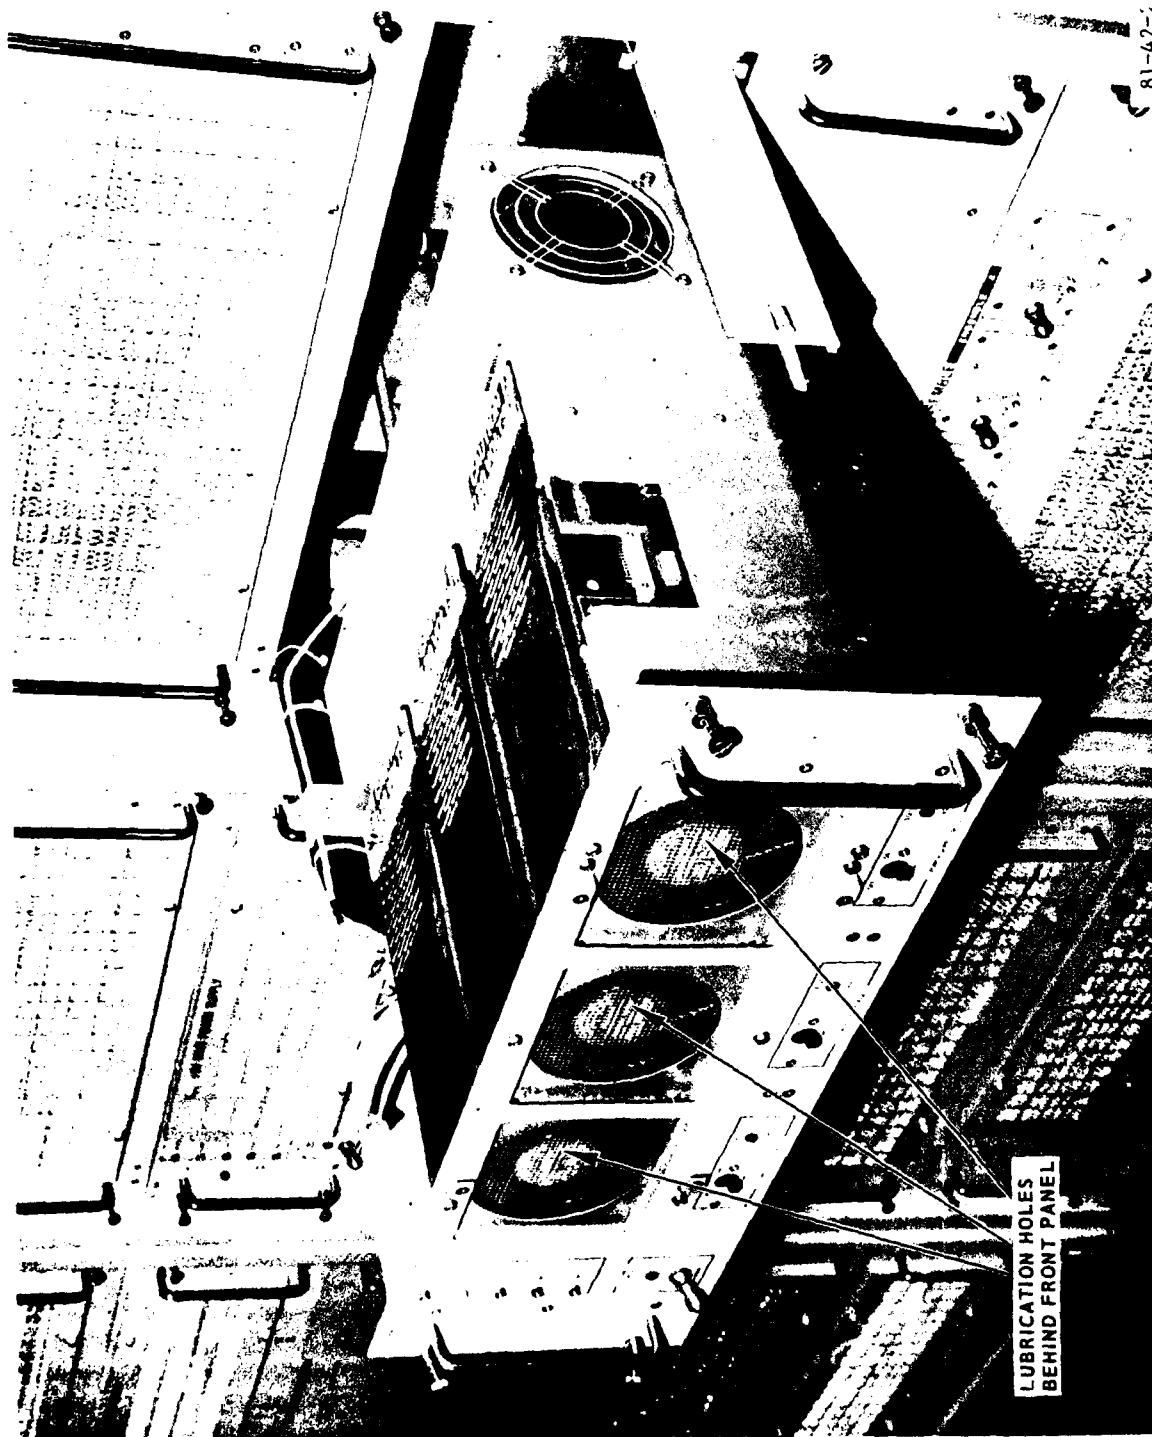
FIGURE 2. TRIPLEX POWER SUPPLY COOLING FANS

COOLING FAN PROBLEMS. Cooling fan failures occurred in the bus lines and the 5-volt triplex power supplies. Of the 12 chargeable bus line failures, 9 involved defective cooling fans. Of the 8 chargeable triplex power supply failures, 5 involved defective Boxer fans. This type of fan has an enclosed oil wick for lubricating purposes. These wicks run dry and are difficult to relubricate because of their inaccessibility. (Figure 2 illustrates this inaccessibility.) Consequently, the fans fail. The lubricating hole is in back of the fan, away from the front panel of the triplex drawer. To gain accessibility, it is necessary to remove the module from the triplex drawer and then disassemble the module to remove the fan.
